Acer Iconia One 7 Repairability Assessment

Repairability assessment of the Acer Iconia One 7 Tablet, performed on February 9, 2017.

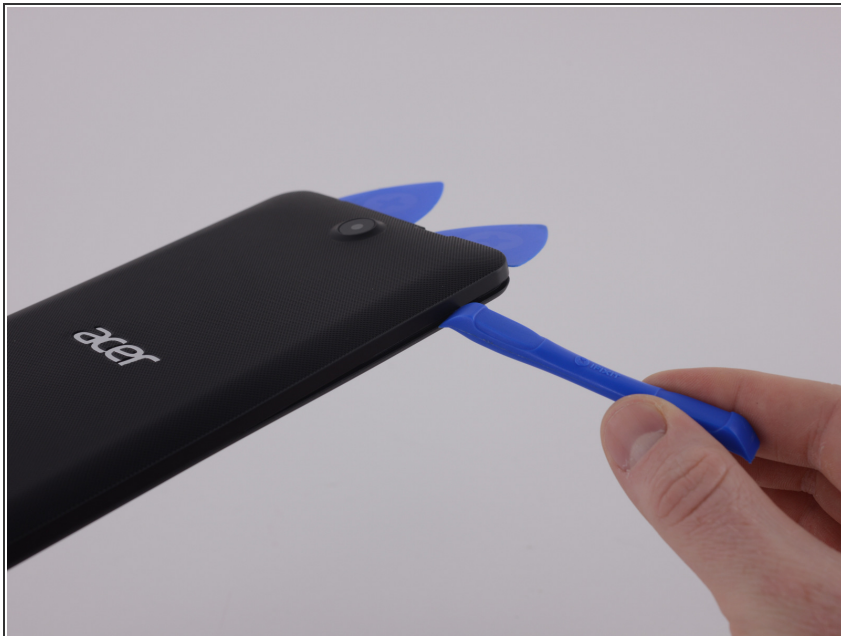
Step 2

- Entry method is to remove the rear bathtub case, the seal is easy to break with opening tools.
- The bathtub case is attached to the front display panel by soft plastic clips and without adhesive.
- ❗ A spring connector connects the motherboard to the bathtub case so no need to worry about damaging fragile cables during removal.

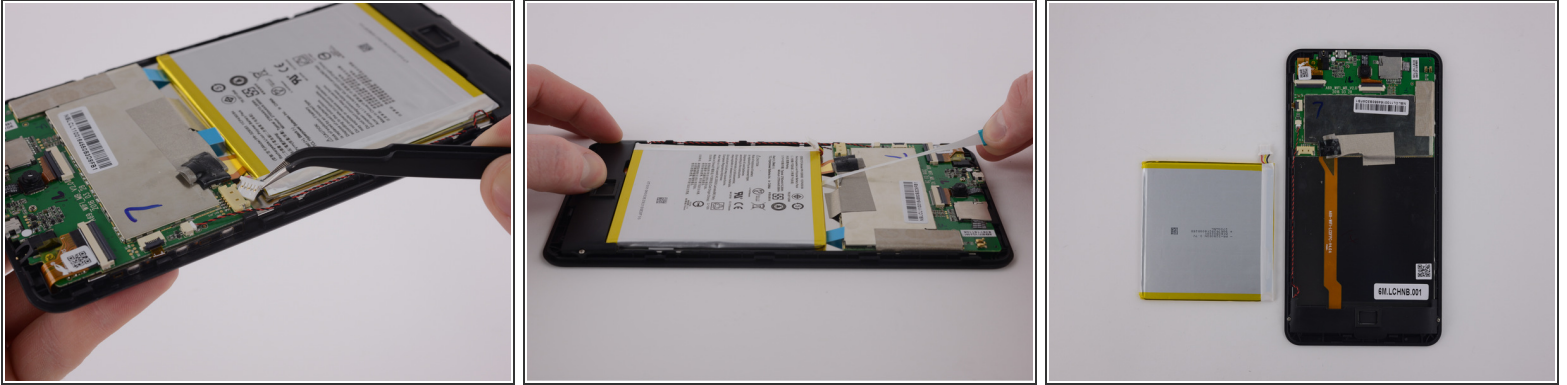
Step 3

- The battery cable runs short and requires a careful and precise wiggle to remove its connection from the motherboard.
- Only two adhesive pull tabs secure the battery. This is preferred over adhesive which requires heat and prying to separate.
- ⓘ The adhesive strips will need to be replaced after removal.

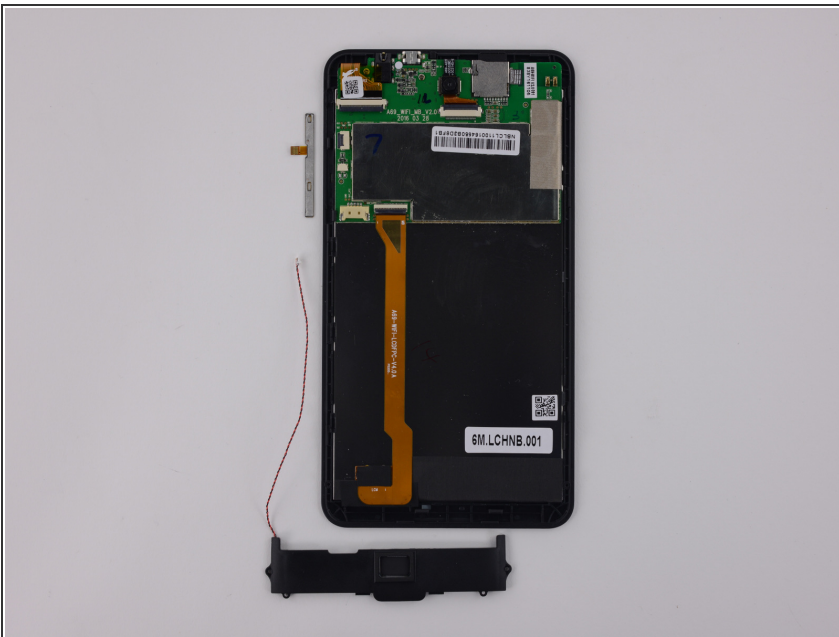
Step 4

- Layer of components removable upon opening: power/volume button cable, loudspeaker.
- The power/volume button cable is lightly secured with adhesive.
- Two Phillips #0 screws secure the loudspeaker housing.

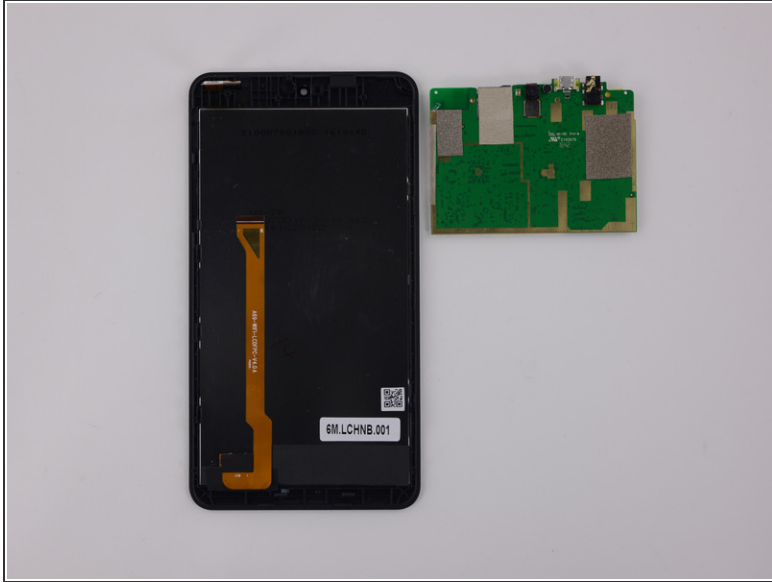
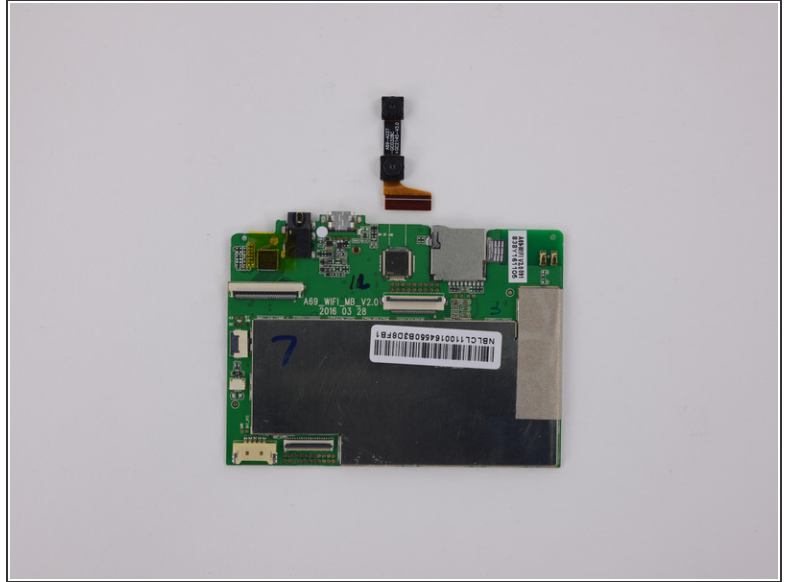
Step 5

- The display, digitizer, and camera cables can be disconnected without removing the motherboard.
- The motherboard is secured to the display frame by three Phillips #0 screws.
- The Micro-USB port, headphone jack and microphone are soldered to the motherboard. These are common failure points and it would be better if they could be individually replaced.
- The front and rear camera are tethered and will need to be replaced together if one where to fail.

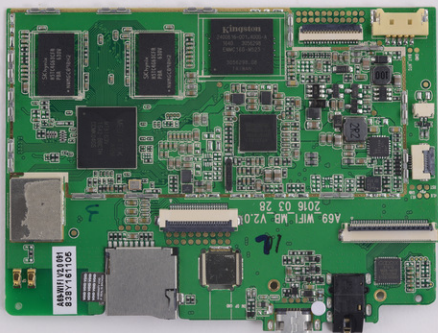
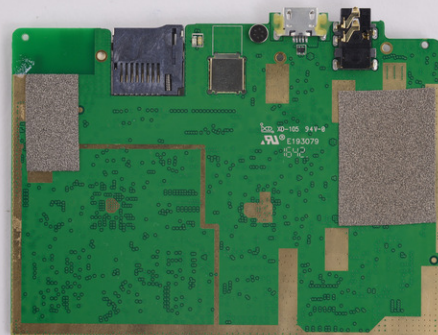
Step 6

- Motherboard reference photos.

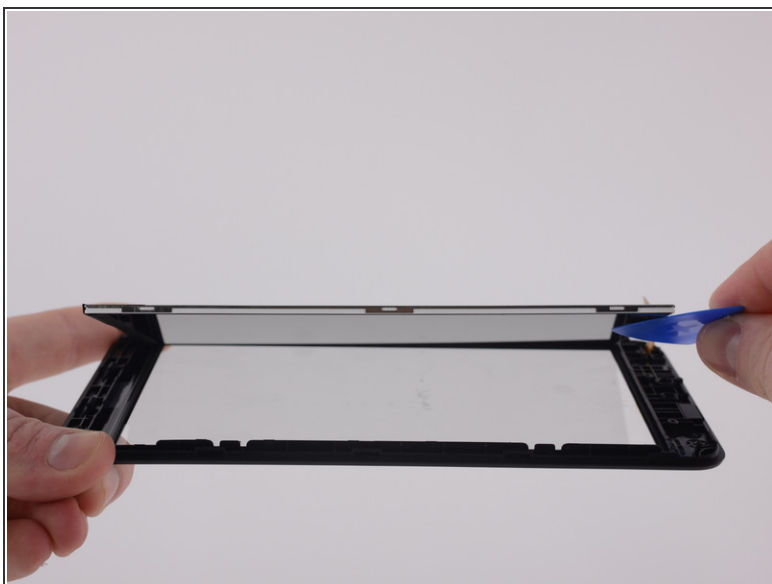
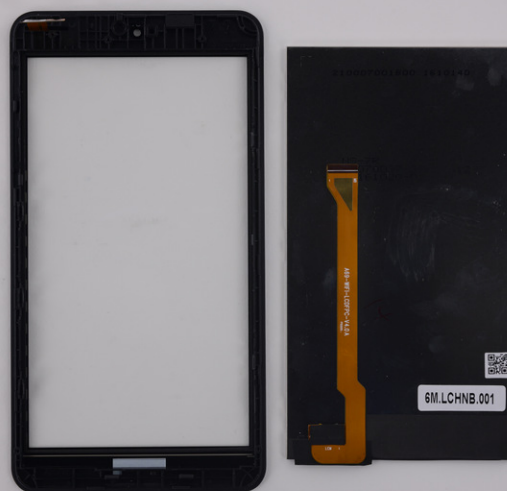
Step 7

- The digitizer is fused to the front case but the LCD display can be isolated by unclipping it from the assembly with an opening tool.

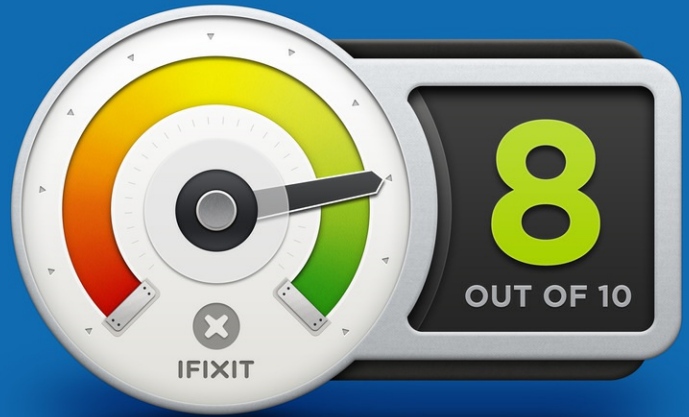
REPAIRABILITY SCORE:

- The Acer Iconia One 7 earns an **8 out of 10** on our repairability scale (10 is the easiest to repair):
 - LCD and front glass are not fused and can be replaced individually.
 - Battery is easy to replace.
 - Modular design allows replacement of many individual parts.
 - Standard Phillips screws used throughout.
 - High wear components soldered in place, which increases replacement costs.
 - Manufacturer does not provide user-accessible repair documentation.
